Manhole Inspection Summary

Manhole # S17K__044MH

Location Address: **FREDERICK AV** Cross Street: **S WARWICK AV**

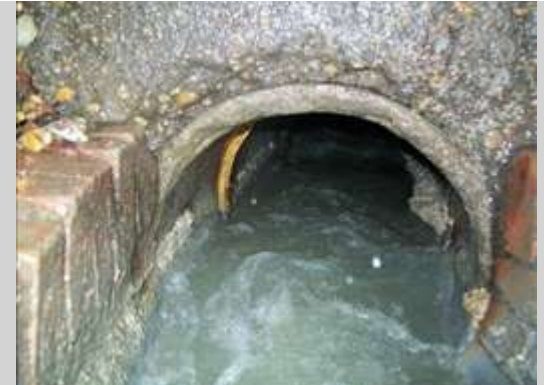
12 O'Clock Outflow

Pipe Height: **15.6** (in.) Rod and Bar (Angled)
Pipe Material: **Clay** ☐ Pipe Lined
Invert Depth: **22.16** (ft.) Flow Characteristics: **Fast**
Deposits: ☒ None ☐ Mud ☐ Sludge ☐ Debris ☐ Grease
Silt Depth: **0** (in.) Deposits Extent:
Infiltration: **None** Pipe Seal Cond: **Sound**

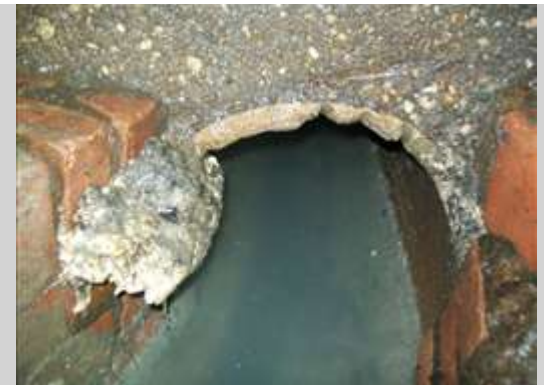
3 O'Clock Inflow

Pipe Height: **12** (in.) Rod and Bar (Angled)
Pipe Material: **Clay** ☐ Pipe Lined
Invert Depth: **21.82** (ft.) Flow Characteristics: **Slow**
Deposits: ☒ None ☐ Mud ☐ Sludge ☐ Debris ☐ Grease
Silt Depth: **0** (in.) Deposits Extent:
Infiltration: **None** Pipe Seal Cond: **Sound**

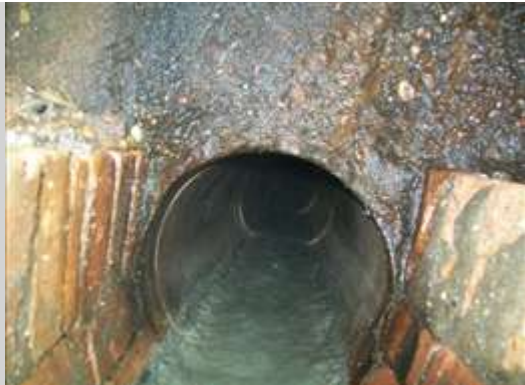
5 O'Clock Inflow

Pipe Height: **10.8** (in.) Rod and Bar (Angled)

Infiltration: **None** Pipe Seal Cond: **Sound**

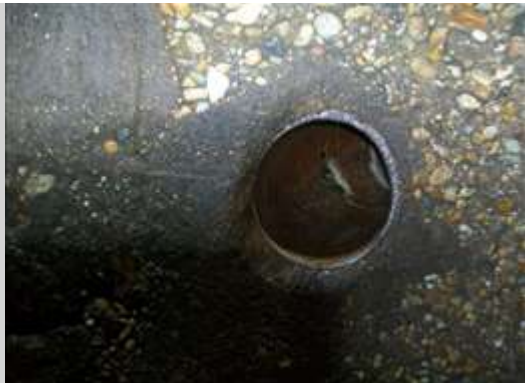
7 O'Clock Inflow

Pipe Height: **8.4** (in.) Rod and Bar (Angled)

Infiltration: **None** Pipe Seal Cond: **Sound**

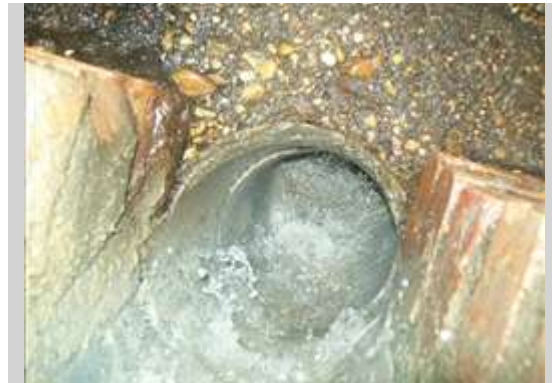
Drop In @ 7 O'Clock

Drop: **Outside** Rod and Bar
Angled: **Yes** Reading: **19.82** (ft.)
Inv Depth: **20.82** (ft.)
Drop Condition: **Open**
